PROPERTY CONDITION ASSESSMENT
OF
WORLD TRADE CENTER PORTFOLIO

ONE WORLD TRADE CENTER

Merritt & Harris, Inc. Project Number 20-251E

December 6, 2000

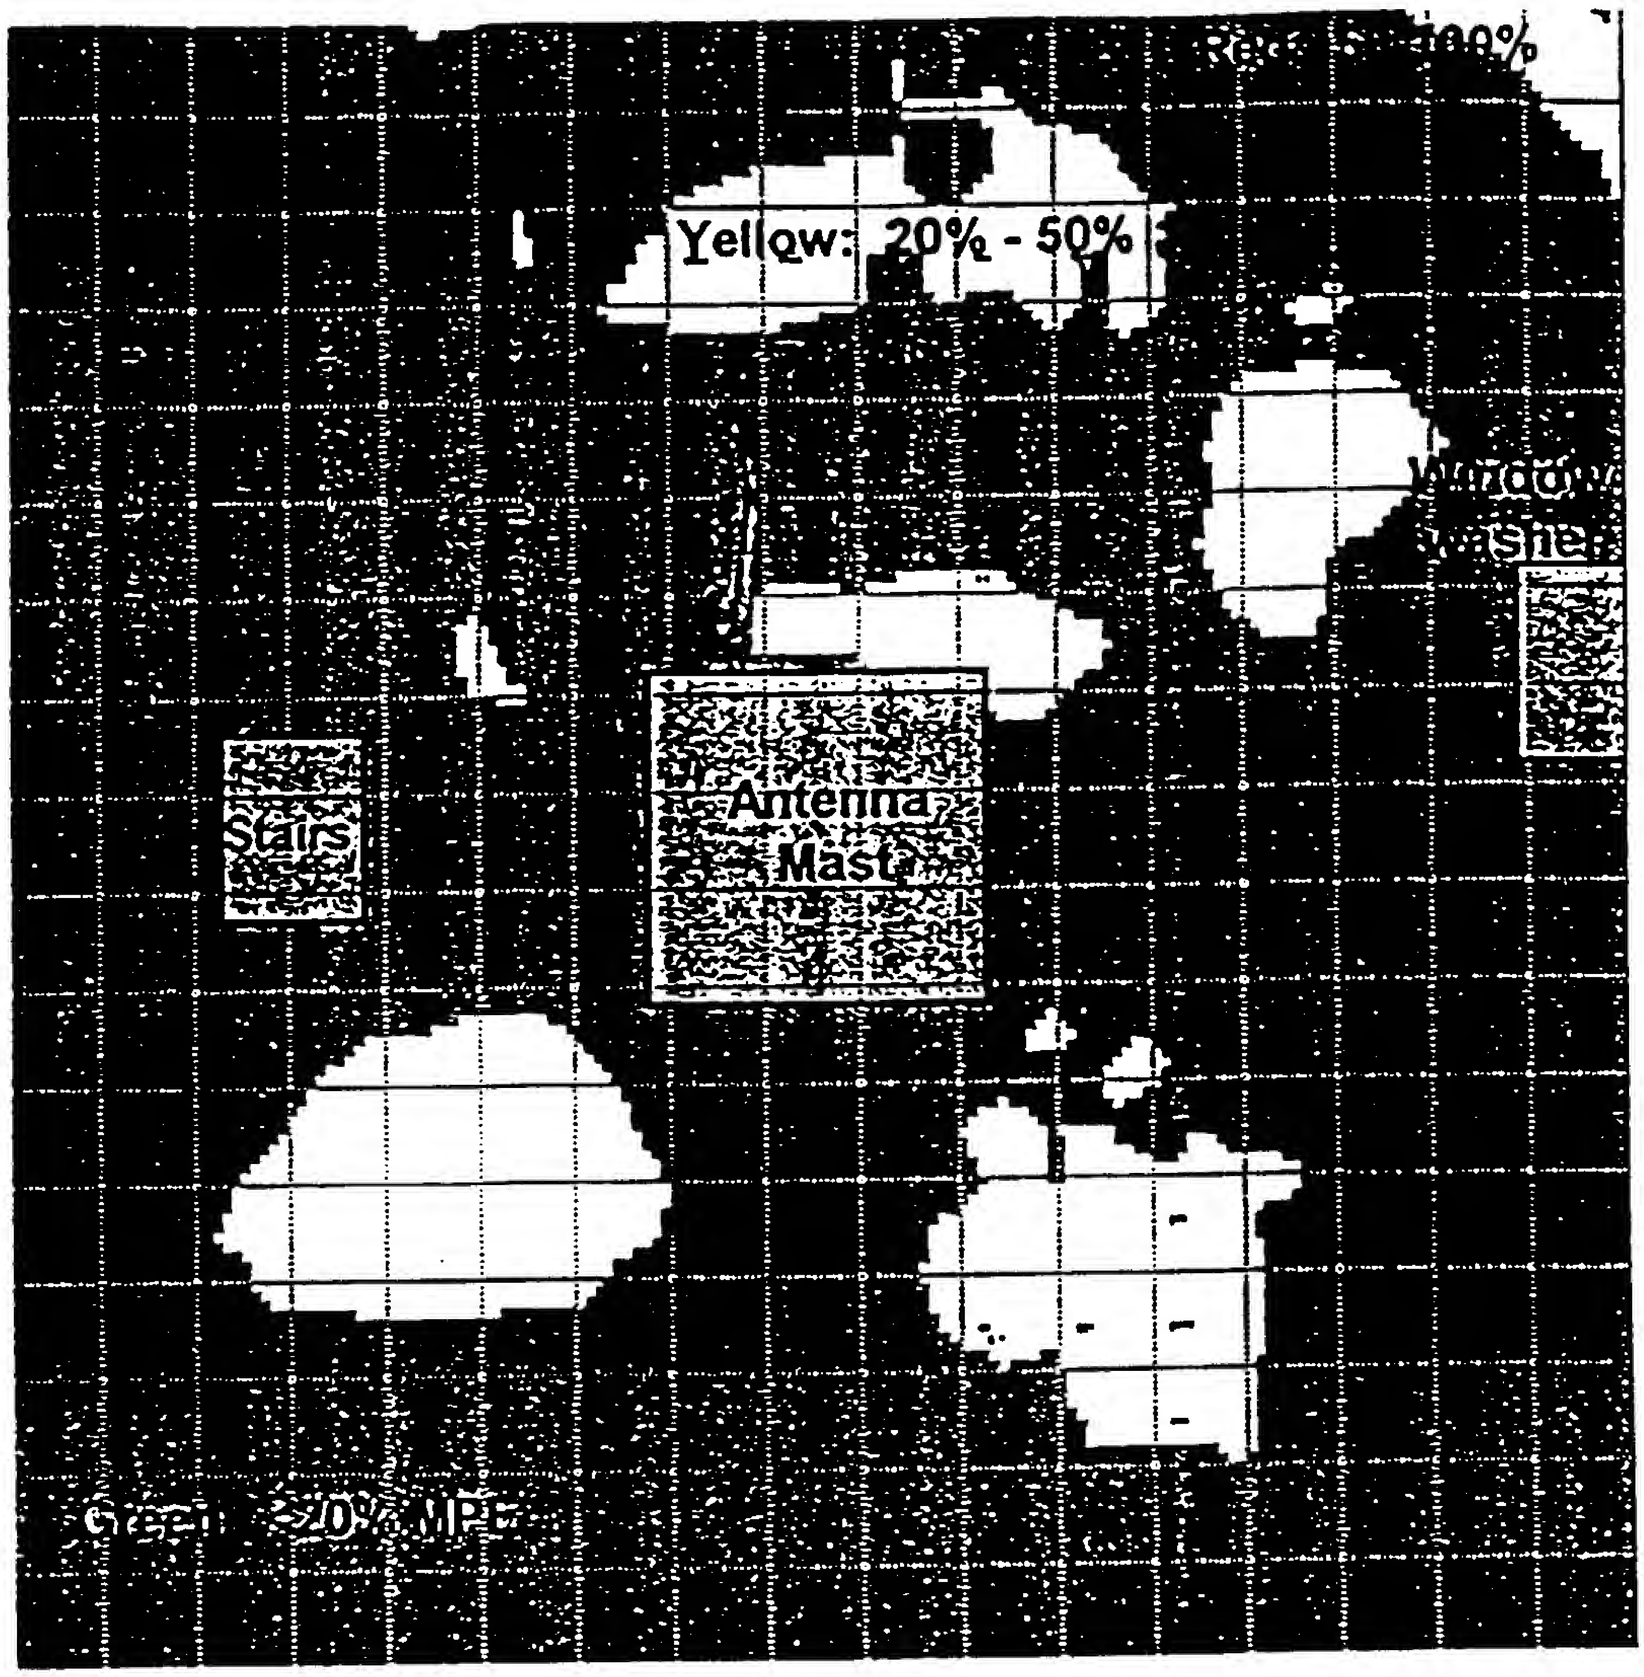
The contribution of the 72 MHz paging link antennas was examined by removing the theoretically calculated fields from those antennas using the RoofView software. This was accomplished by making custom modifications to RoofView which permitted the computation of those fields, as would be performed during a conventional roof analysis, but then subtracting those results for each pixel on the roof. When this process was accomplished, the maximum RF field on the roof was found to decrease from 70.2% (with the 72 MHz pagers included) to 56.6% of the MPE, thereby increasing the amount of roof area subject to fields less than 20% of the MPE. Under this condition, only 15% of the roof area (3,943 square feet) was found to exceed 20% of the MPE. Figure 8 illustrates the resulting colorized roof map of this hypothetical mode of operation.

Figure 8. Roof map of normal broadcast ambient RF fields with contribution of 72 MHz paging links removed via analysis with RoofView Maximum field is 56.6% MPE.

Statistical summary of RF Fields on WTC roof (see Figure 8)		
Percent occupational MPE range (%)	Roof area in this range (ft^2)	Percent of roof area in this range (%)
0-20	23262	85.51
21-50	3937	14.47
51-100	6	0.02
>100	0	0.00

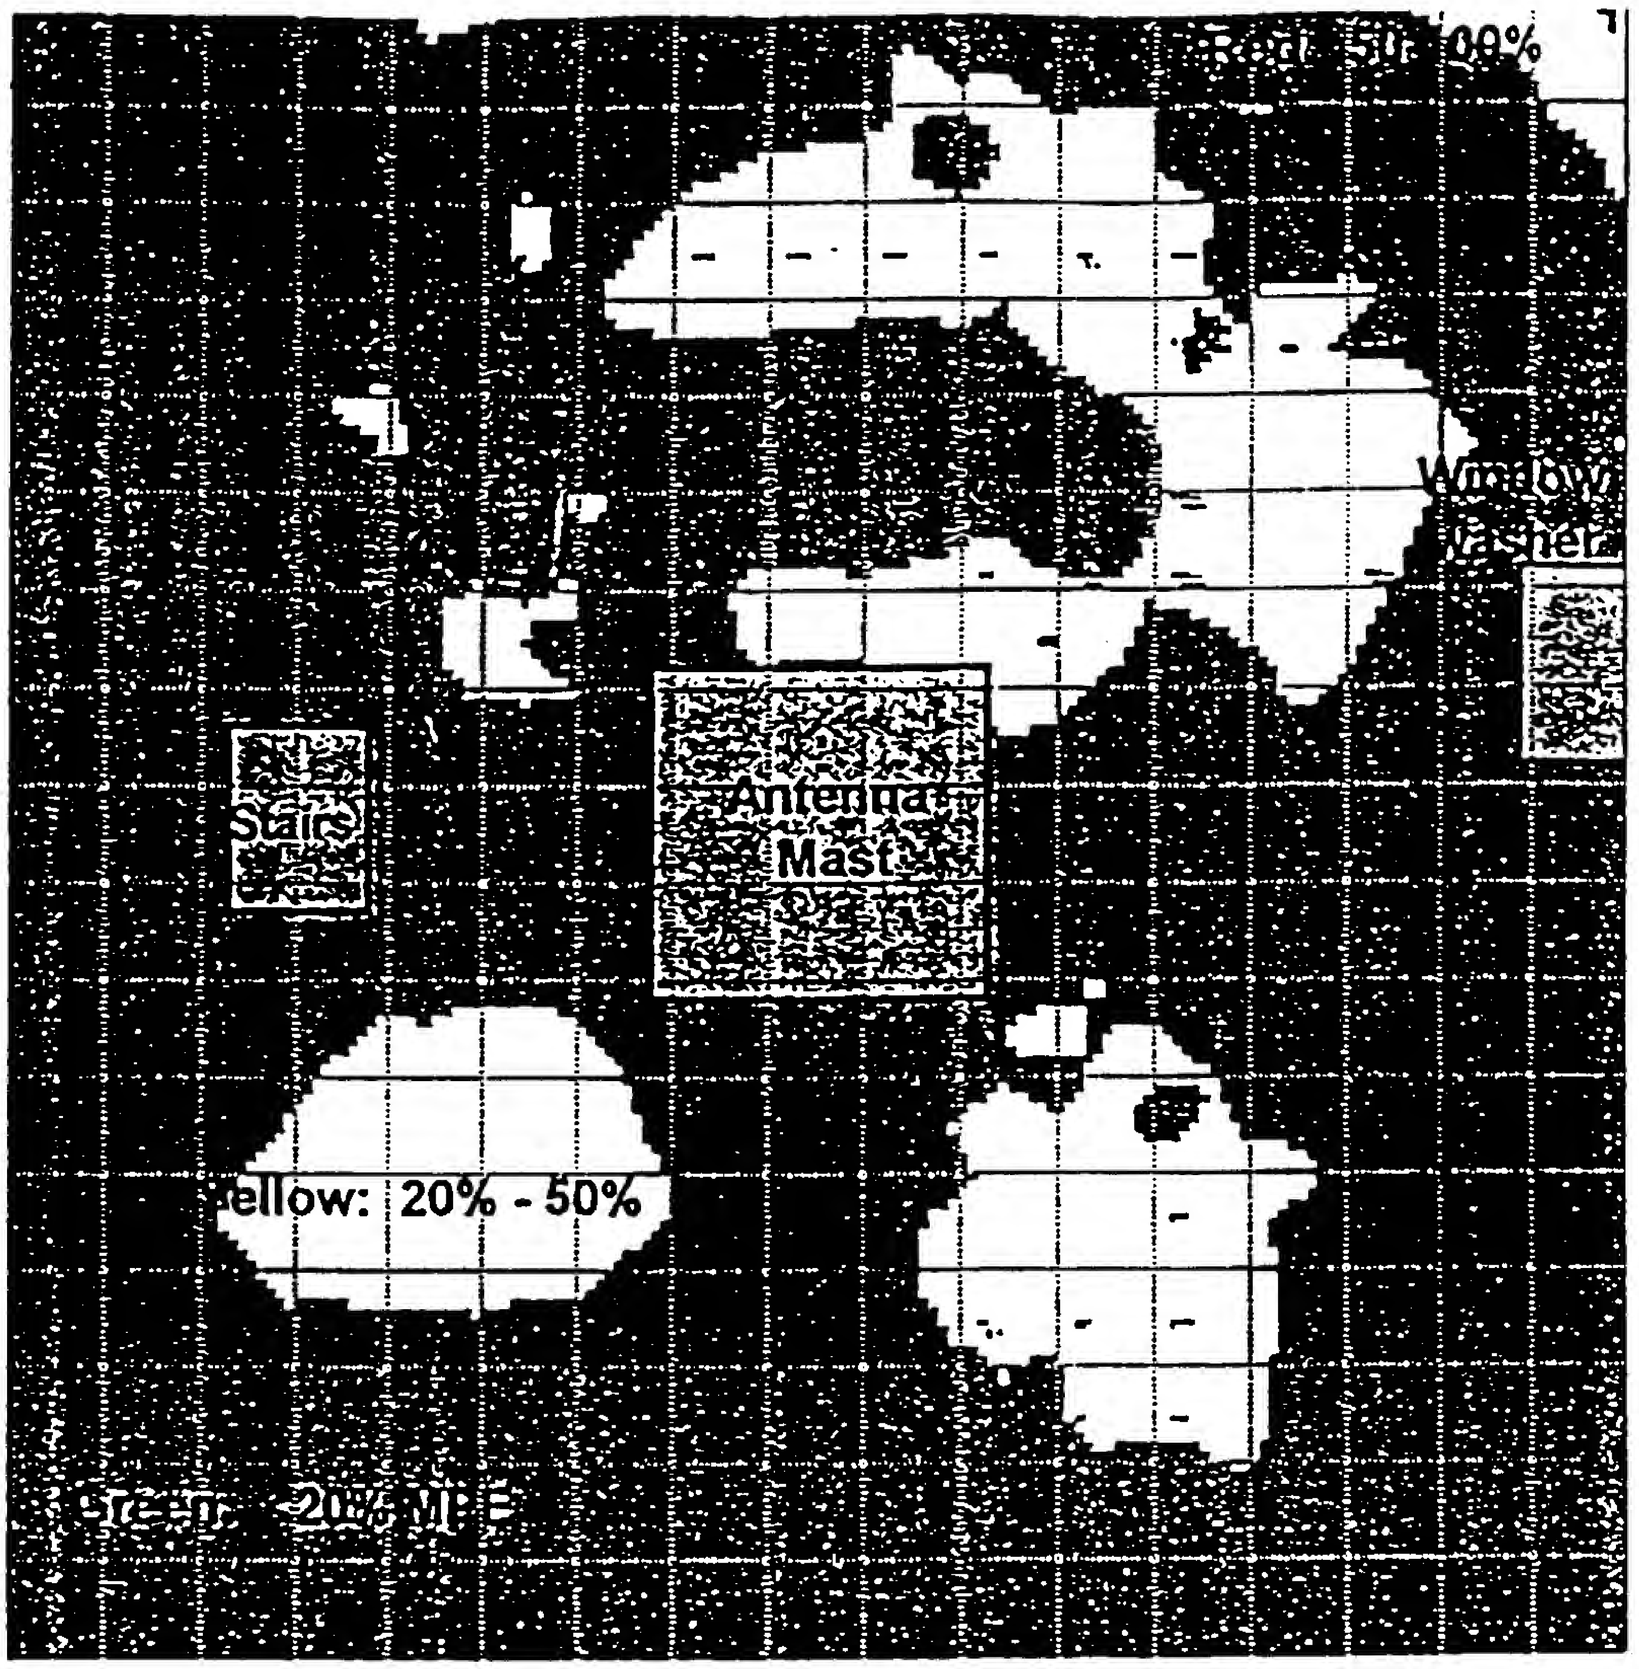
were left as is. The results are shown in Figure 9 and indicate that the maximum RF field level would decrease from 70.2% of the MPE (with the paging links at their present mounting heights) to 57.2% of the MPE. RoofView was first used to subtract the calculated fields from each paging link antenna at each roof pixel, and then to add their contribution back into the ambient, measured broadcast field levels for the condition of being raised to six feet above the roof where applicable.

Figure 9. Roof map of RF fields during normal broadcast operations with calculated effect of raising 72 MHz paging links to 6 feet above roof No other wireless antennas active Maximum field is 57 2% MPE

Statistical summary of RF Fields on WTC roof (see Figure 9)		
Percent occupational MPE range (%)	Roof area in this range (ft^2)	Percent of roof area in this range (%)
0-20	21878	80 42
21-50	5318	19 55
51-100	9	0 03
>100	0	0 00

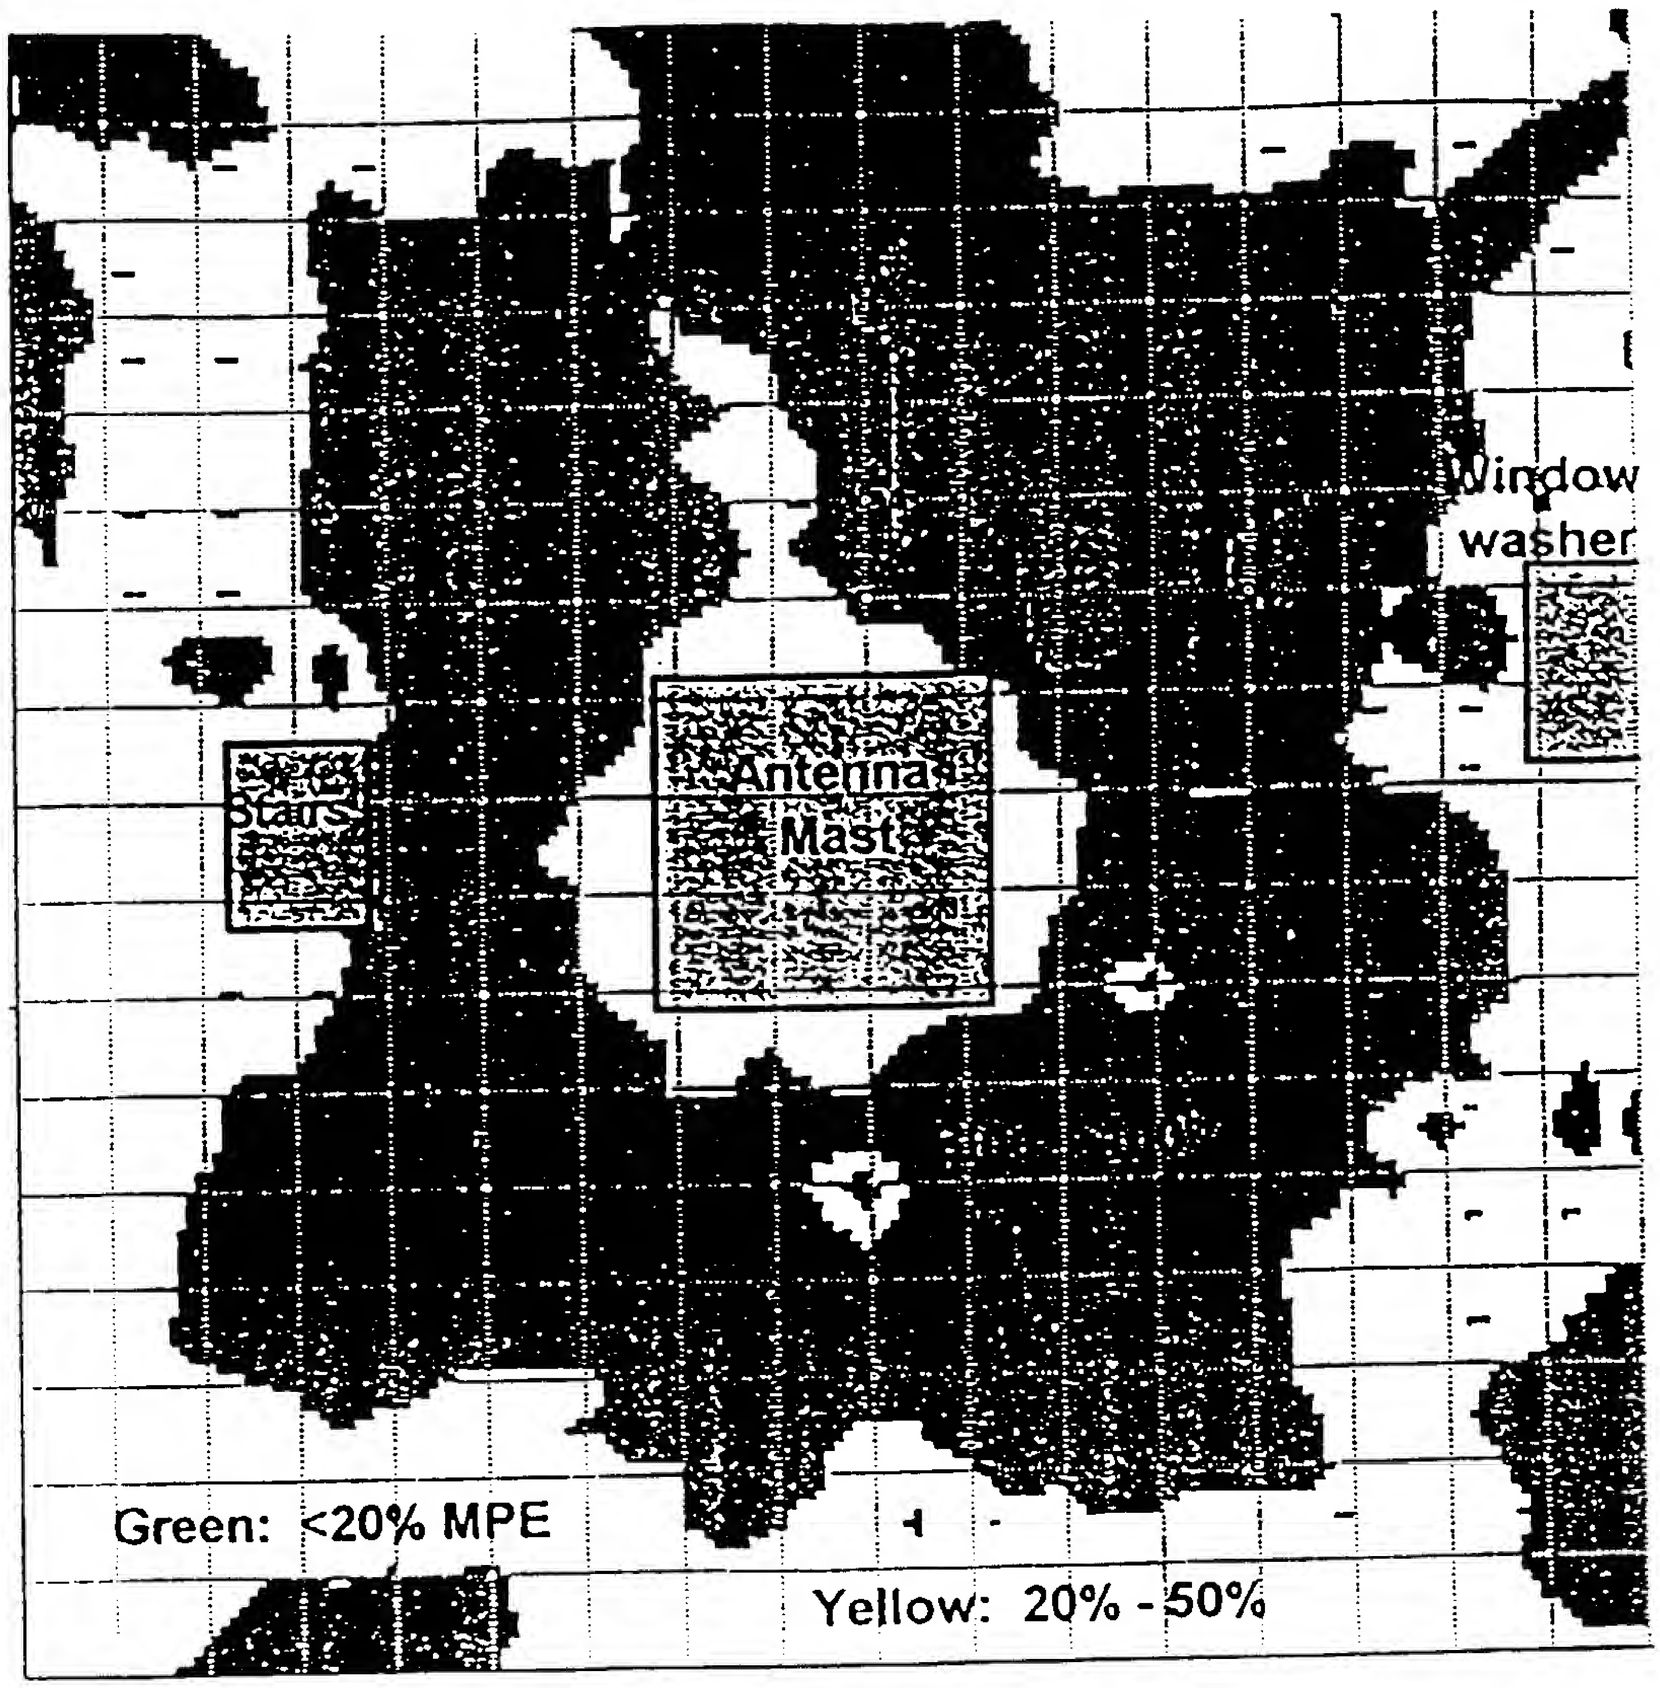
Figure 11. Roof map showing measured ambient RF fields on roof of north tower of World Trade Center during tower maintenance mode of broadcast operations with contributions from 72 MHz paging links included Maximum field is 147.0% MPE.

Statistical summary of RF Fields on WTC roof (see Figure 11)		
Percent occupational MPE range (%)	Roof area in this range (ft^2)	Percent of roof area in this range (%)
0-20	1043	3.83
21-50	11728	43.11
51-100	13298	48.88
>100	1136	4.18

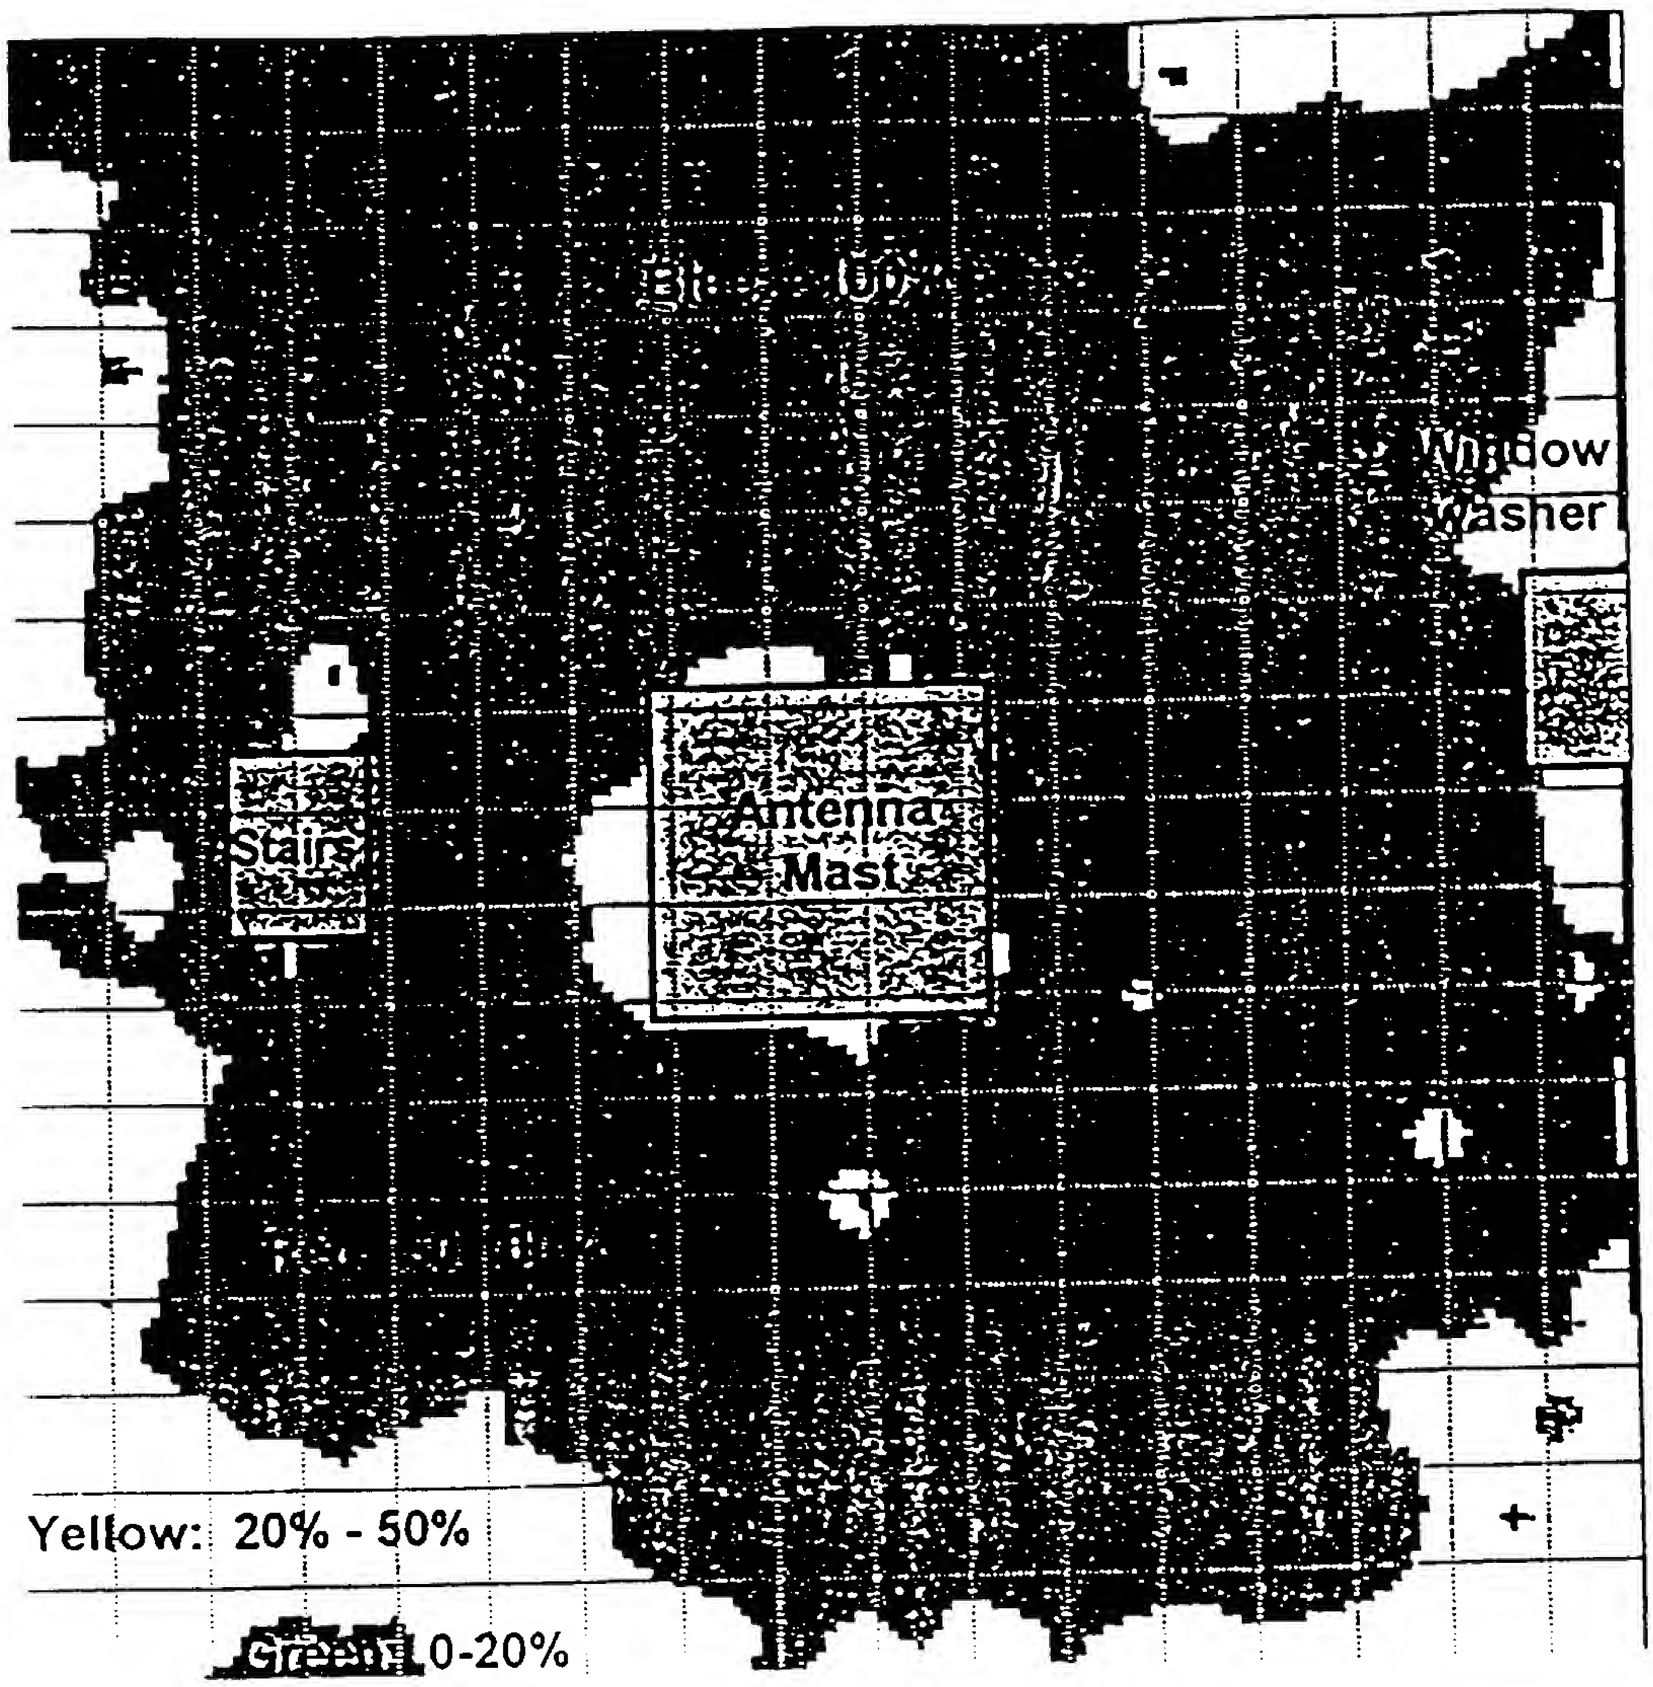
Figure 12. Roof map showing measured ambient RF fields on roof of north tower of World Trade Center during tower maintenance mode of broadcast operations with calculated contributions from all wireless telecommunications antennas included Maximum field is 352% MPE

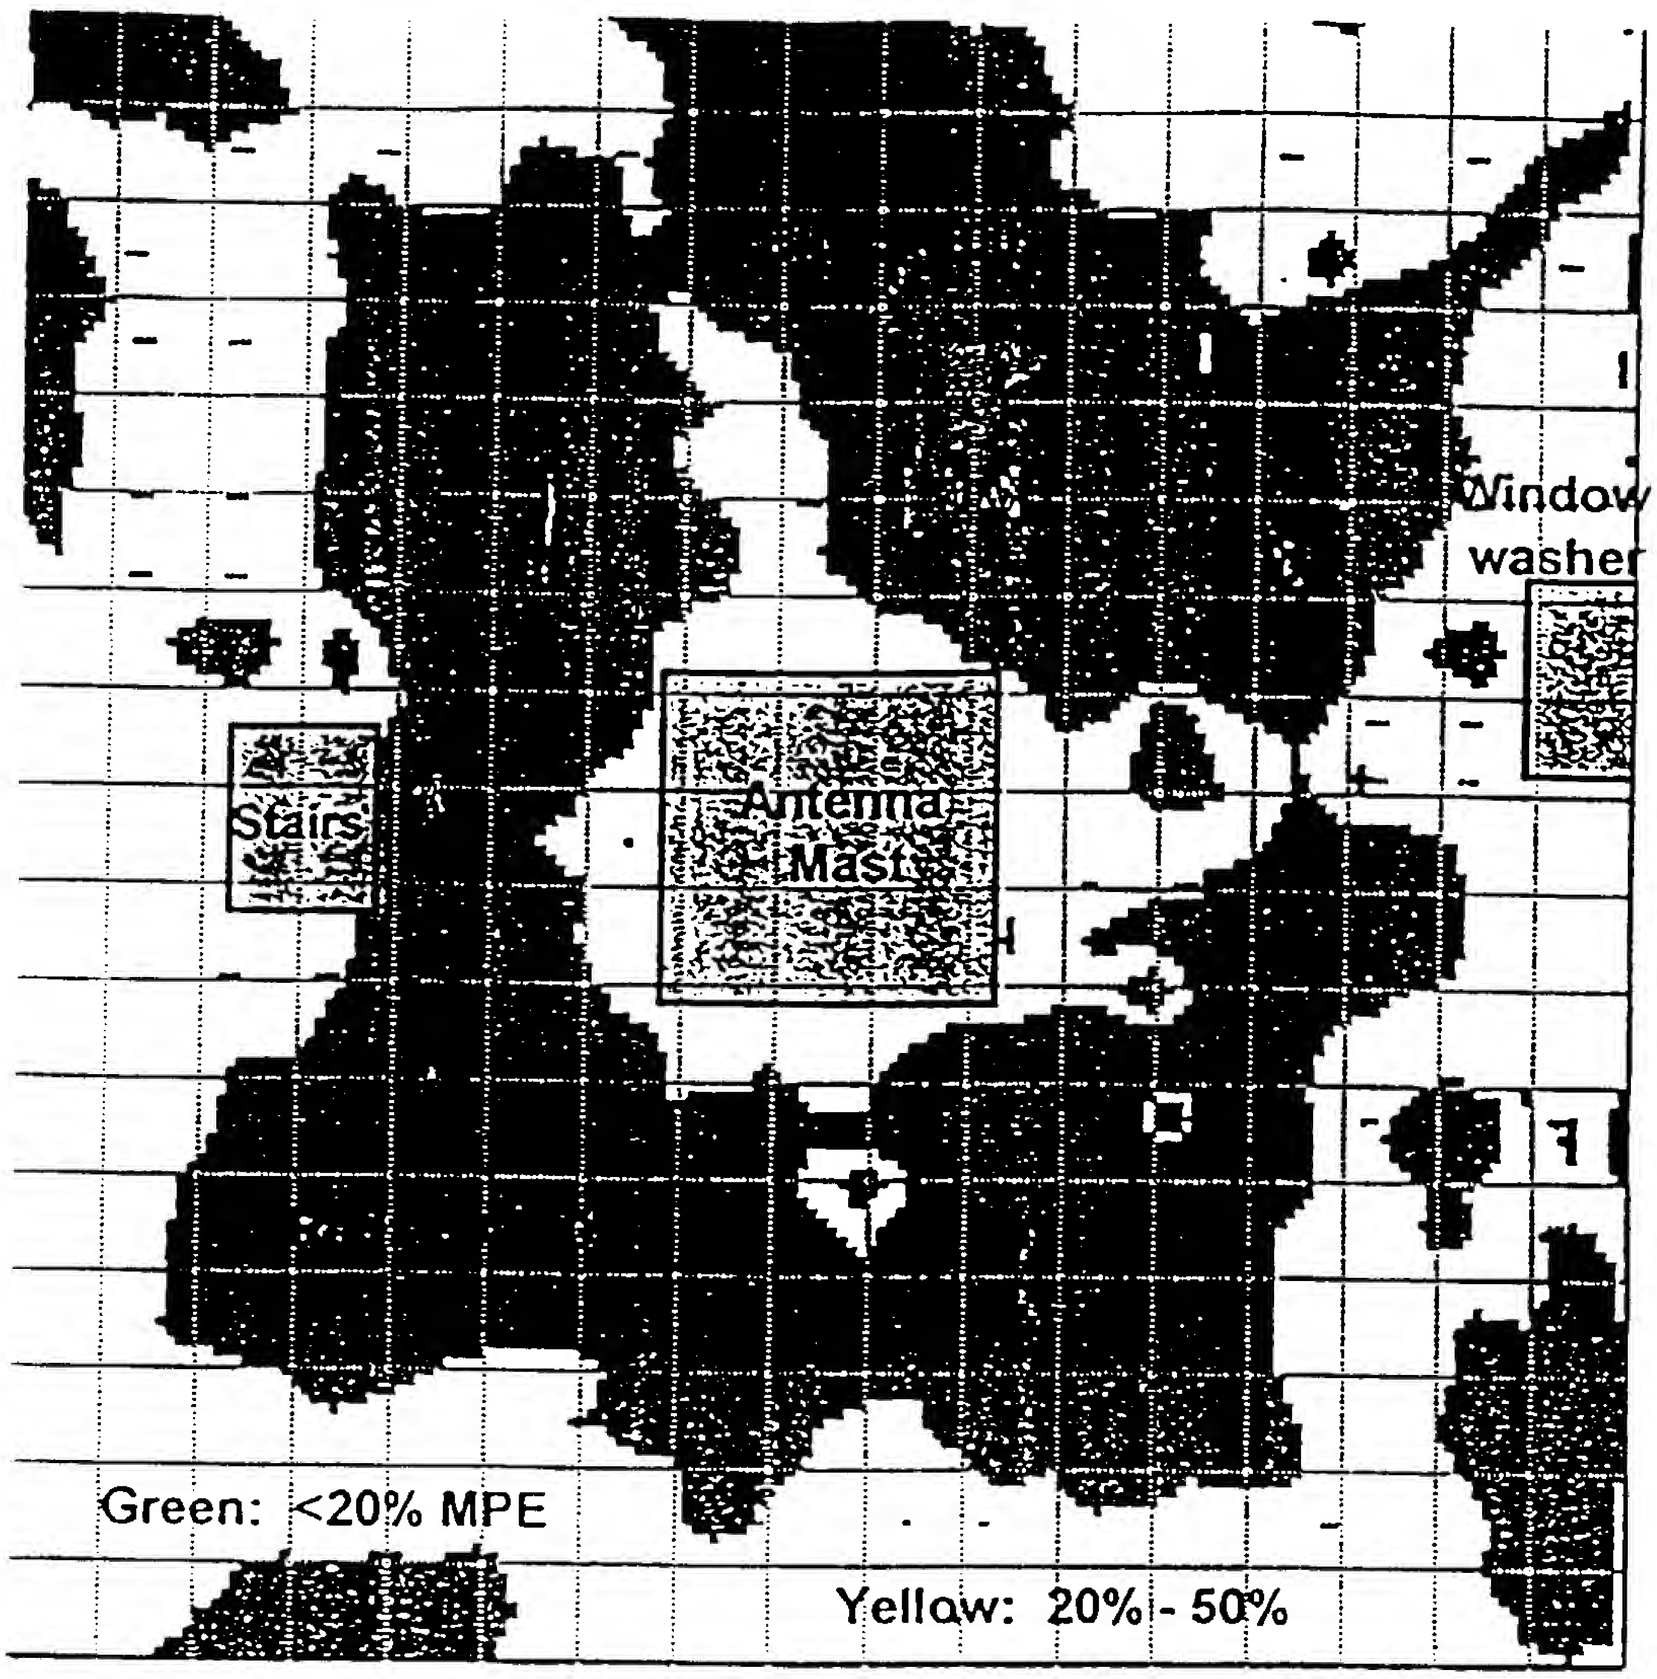
Figure 13. Roof map of RF fields during tower maintenance mode with contribution of 72 MHz paging links removed with RoofView Maximum field is 138.3% MPE.

Statistical summary of RF Fields on WTC roof (see Figure 13)		
Percent occupational MPE range (%)	Roof area in this range (ft^2)	Percent of roof area in this range (%)
0-20	1546	5.68
21-50	13108	48.18
51-100	12035	44.24
>100	516	1.90

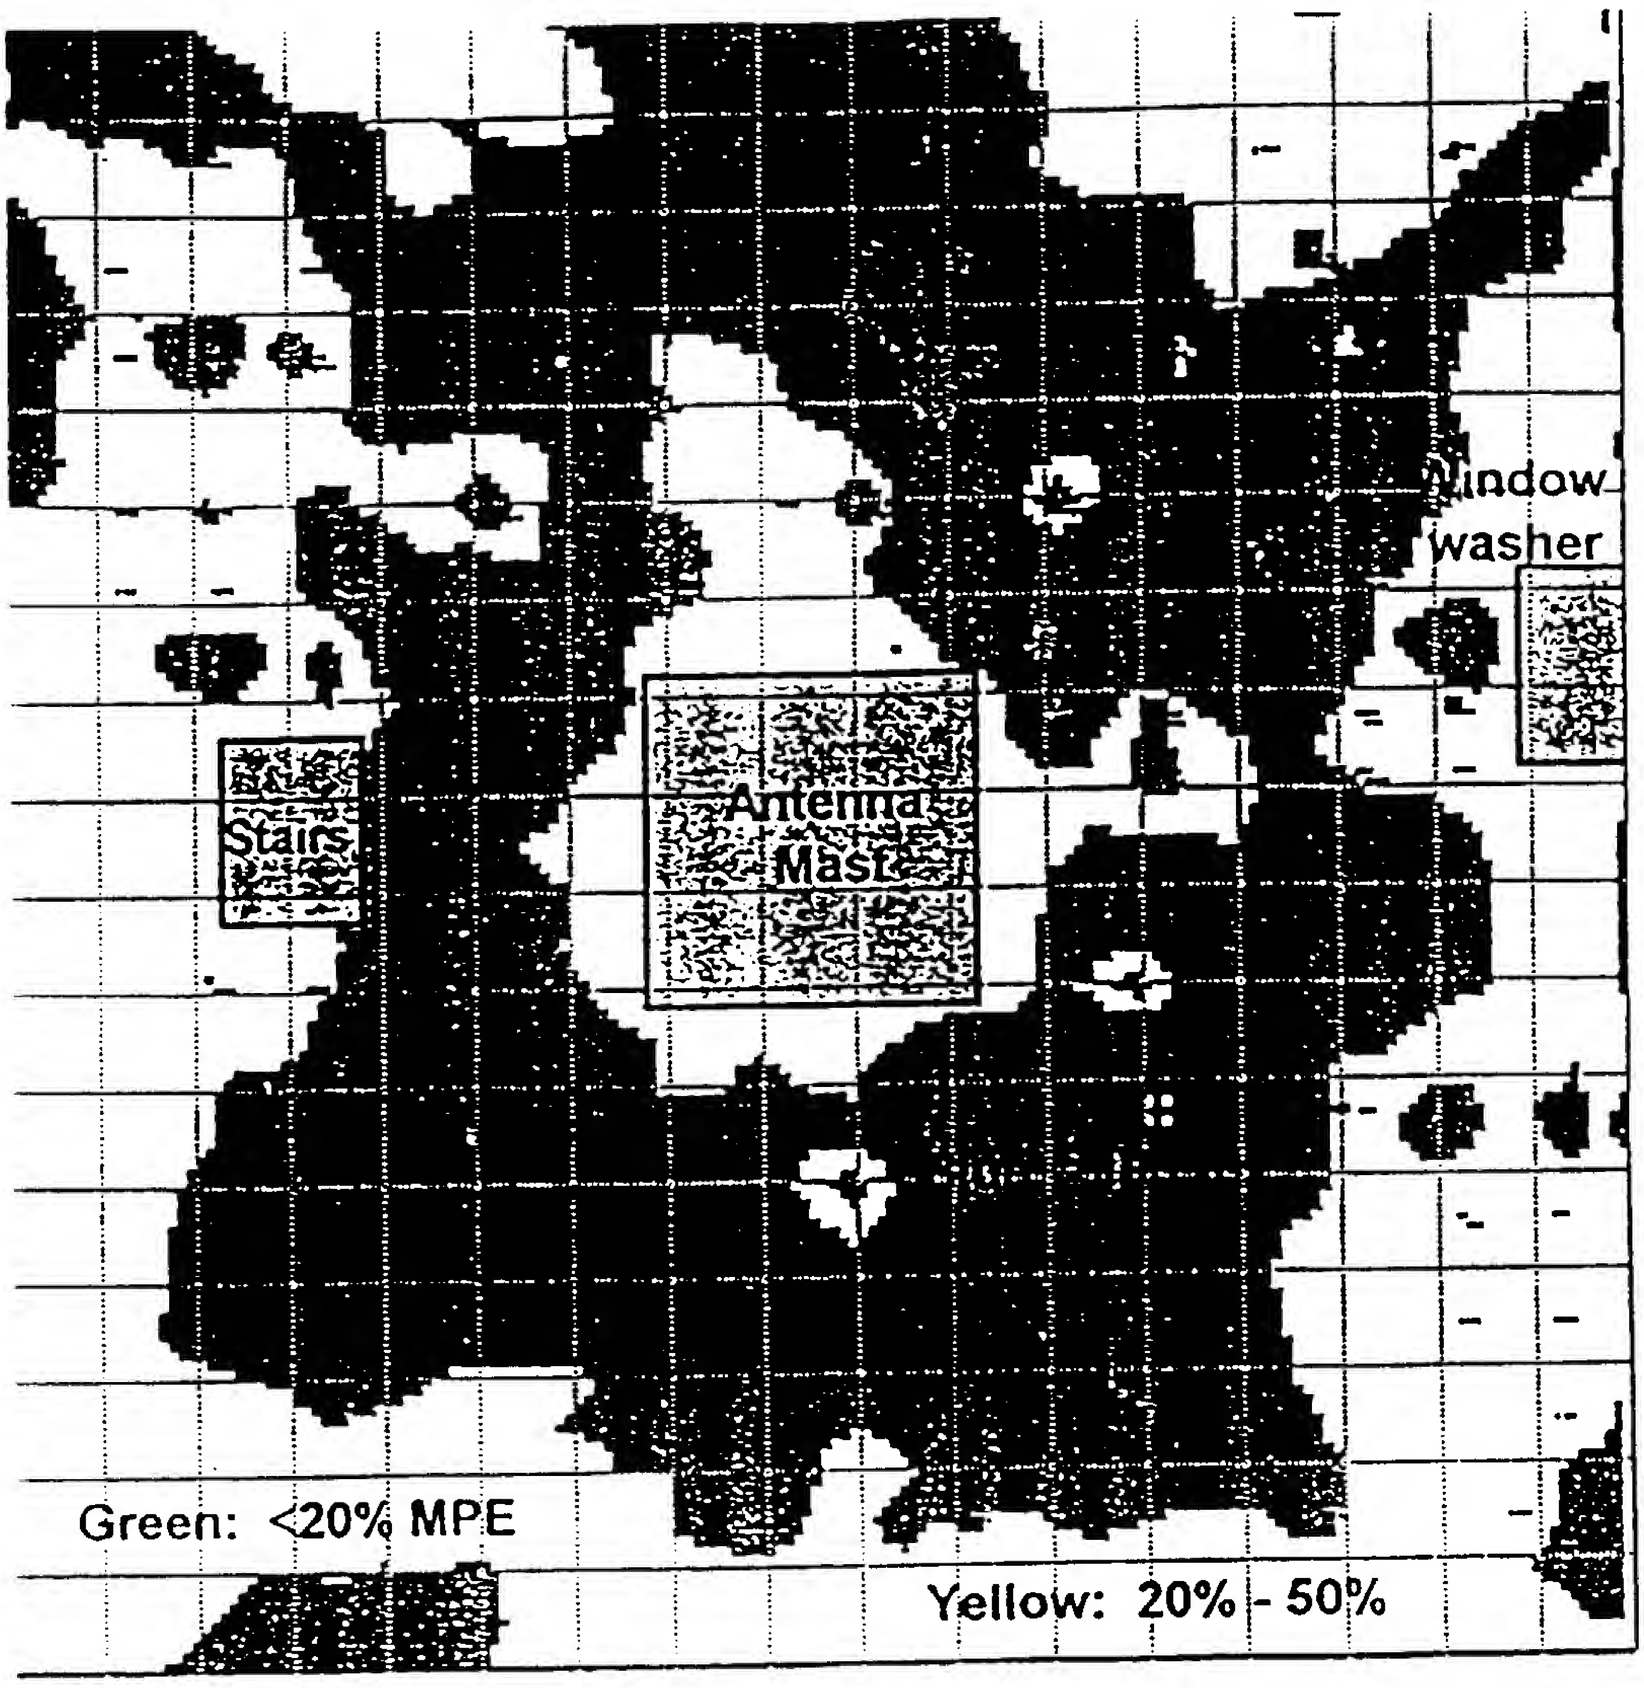
Figure 14. Roof map showing RF fields during broadcast tower maintenance mode with calculated effect of all wireless antennas raised to at least 6 feet above roof
Maximum field is 144 3% MPE

Statistical summary of RF Fields on WTC roof (see Figure 14)		
Percent occupational MPE range (%)	Roof area in this range (ft^2)	Percent of roof area in this range (%)
0-20	992	3.65
21-50	12641	46.47
51-100	12879	47.34
>100	693	2.55

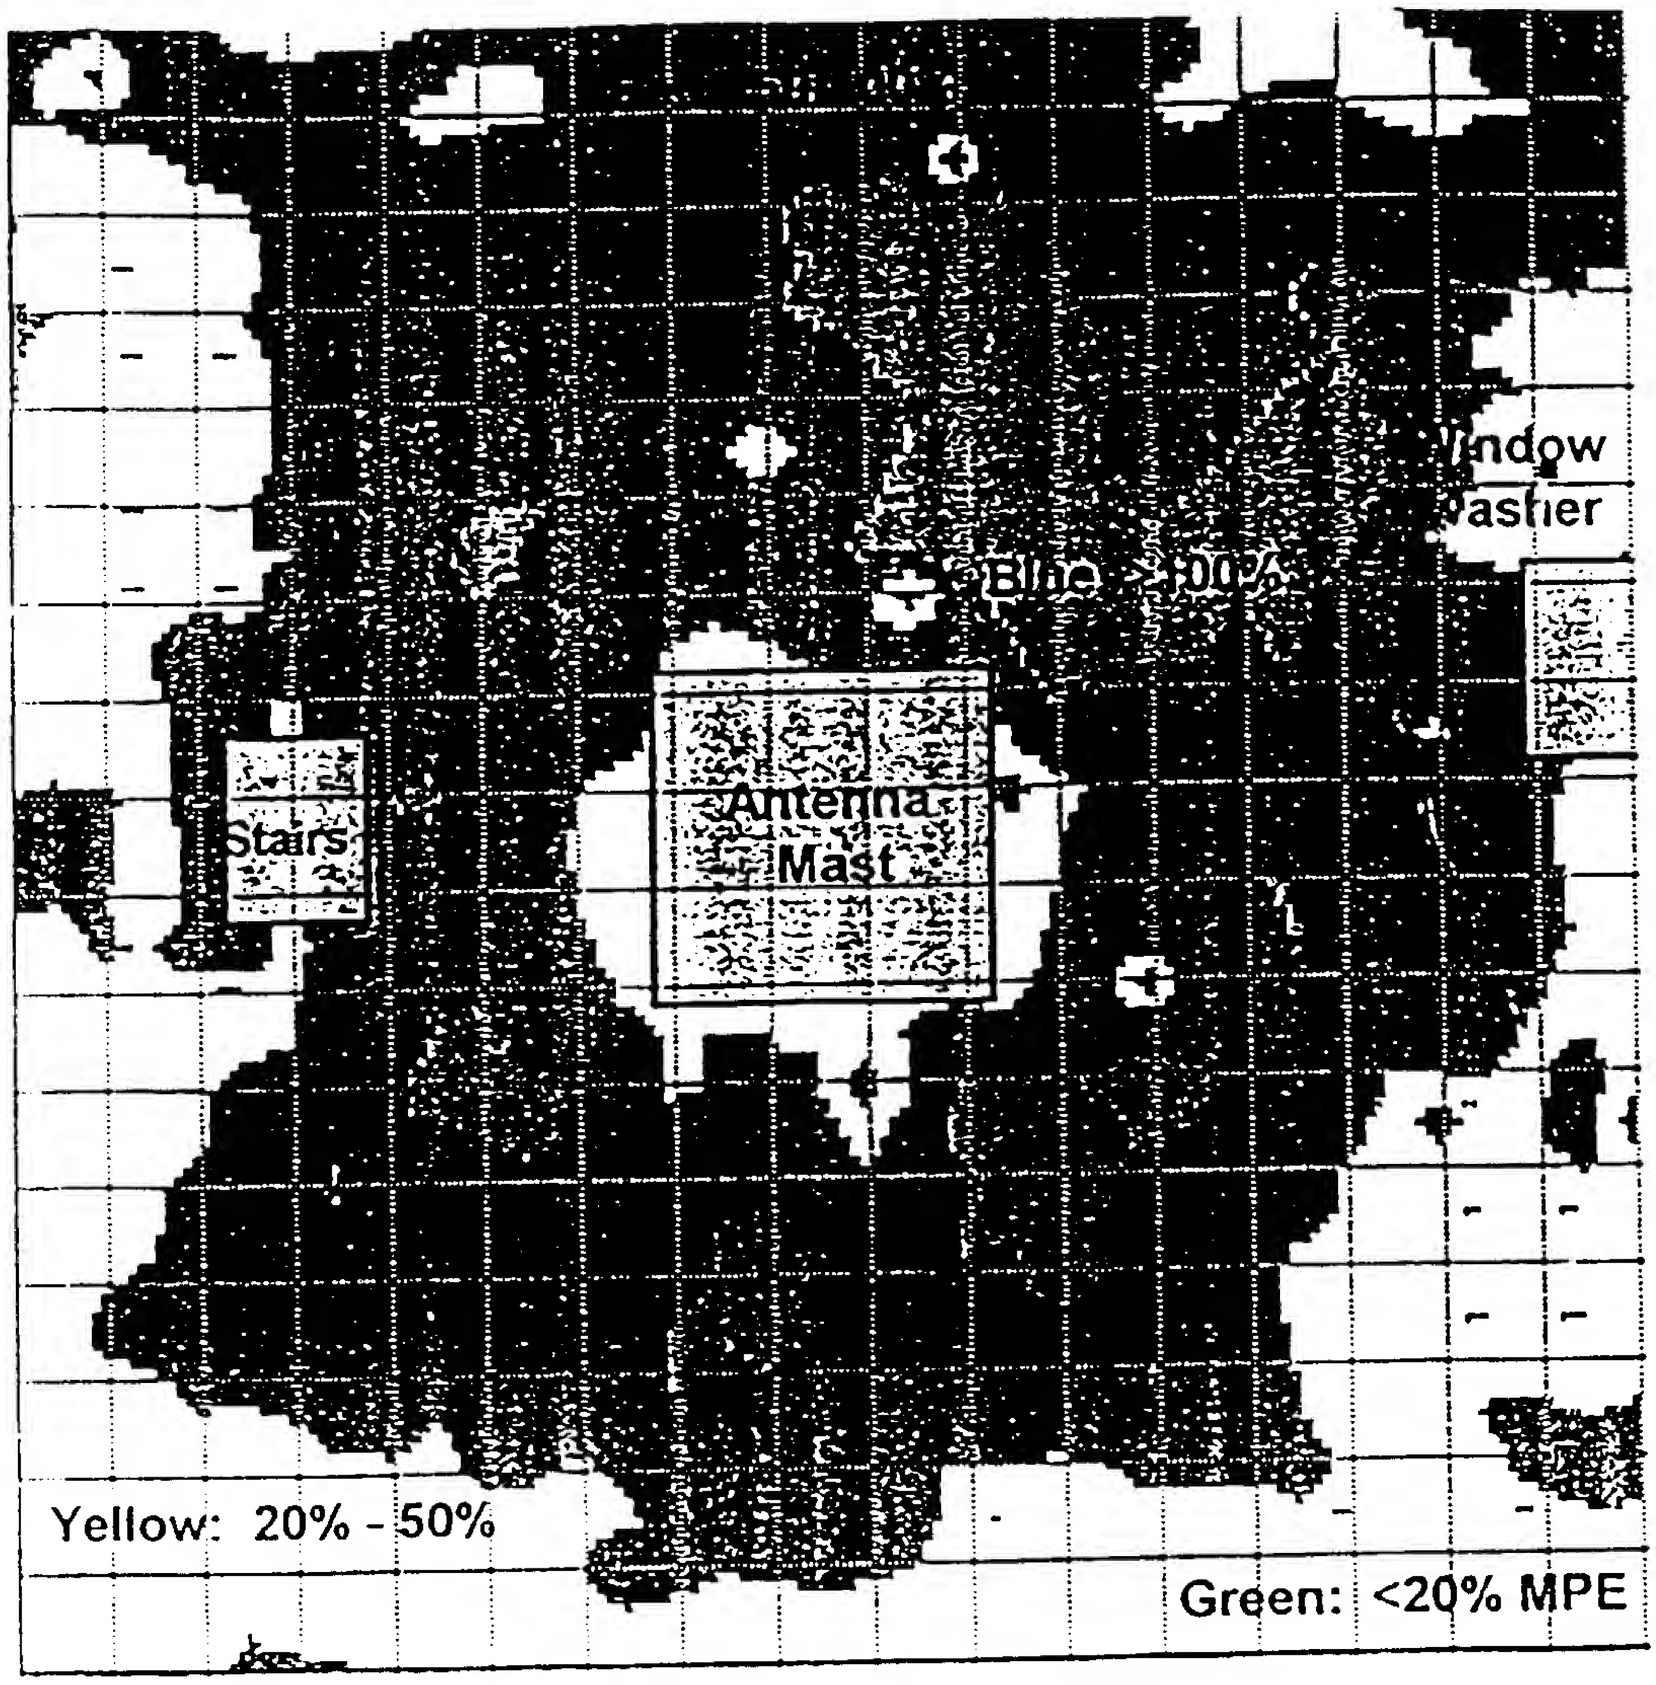
Figure 15. Roof map showing measured ambient RF fields on roof of north tower of World Trade Center during emergency backup broadcast operations with contributions from 72 MHz paging links included. Maximum field is 156.3% MPE
